**Flood Control Project Maintenance
Levee Inspections**
LMA District Cover Sheet
Spring 2017 Levee Inspection Results

Reclamation District No. 2063 Crows Landing

Spring 2017 Levee Inspection Results

Waterway			Bank	Unit Miles
Unit No. 01 San Joaquin River			Right	10.44
	Spring (March - May)	Summer (June - August)	(September - November) Fall	Winter (December - February)
Unit Maintenance Rating (Fall Only)				
Date of Inspection	4/11/2017 - 4/11/2017			
DWR Inspector	Richard Willoughby			
Accompanied By

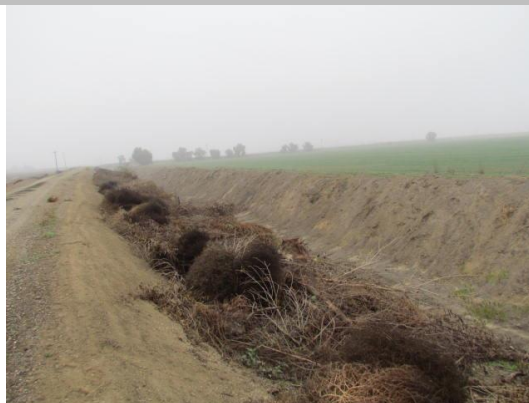
Photo 1 of 3 : SP_2017_RD2063_112_18_20170411_00006.jpg

Looking north at ditch on landside berm and toe.

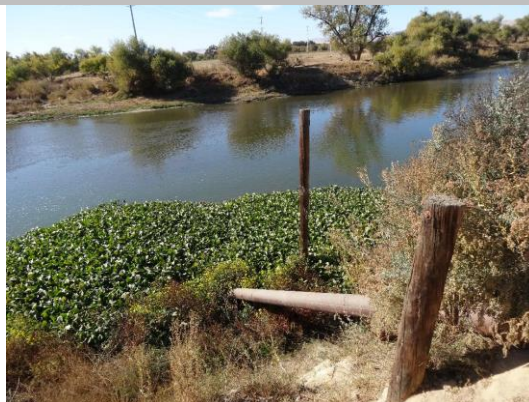
Photo 2 of 3 : UCIP_SP_2017_50216_43161.jpg

WS view: steel pipe immersed into the river. No pump found.

FS_ID:50216
DS_ID:22075
EP_NO: N/A
Repair Type: Non-Urgent
Crossing Status: Indicator Found
UCIP Comments: 08/23/2016: Could not locate pipe during inspection, though it was very prominently visible on the WS bank and LS ditch as per 2013 photos. I confirmed with RD2063 president Joe Sallaberry that the pipe was filled with concrete through the levee but removed at the LS ditch. Could not locate pipe's ends during inspection. No permit exists for this work. Crossing has been downgraded from Urgent to Non-Urgent since we lack documentation verifying proper abandonment.

11/05/2013:- Pipe has visible holes throughout both LS and WS along with pipe deformation. - looks abandoned. Needs proper abandonment.- alfalfa valve on concrete pipe riser on waterside toe.- no slide gate found on waterside. No pump and pile structure found in river.

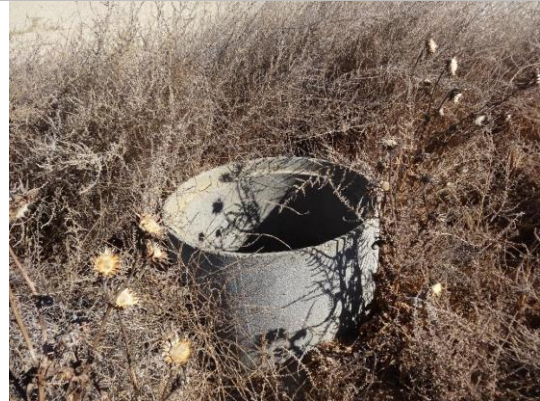
Photo 3 of 3 : UCIP_SP_2017_50216_43160.jpg

WS view: concrete riser with alfalfa valve on levee berm.

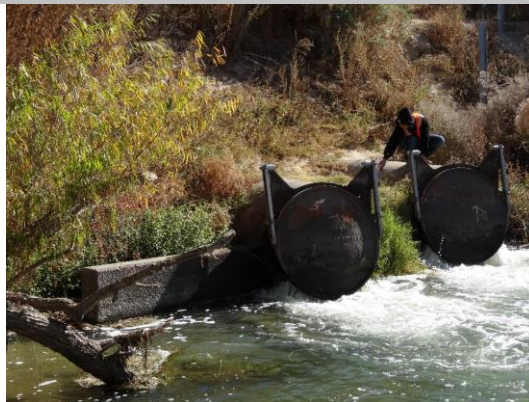
Photo 2 of 3 : UCIP_SP_2017_50218_43203.jpg

Comment Code					
Inspector Comment					
FS_ID:50218					
DS_ID:22076					
EP_NO: N/A					
Repair Type: No Action Needed					
Crossing Status: Found					
UCIP Comments: 08/23/2016: WS flapgates were held open by a piece of wood. Pipes may be used temporarily for irrigation. (K. Fazel - UCIP)11/05/2013: working during the inspection. (P. Amatya - DWR)					
FIELD_STRUCT_DESC: 1 of 2: Gravity drain structure. Two 48-inch CM pipes through the levee 25.5 feet below the crown. Slide gates in CM pipe risers on the waterward slope. Flap gates on the waterward ends. Cobble spillway 70 feet in length to river. (Lateral Drain No. 5) installed by USCE 1961. O&M Manual SJR 006, Sept. 1961.					
FS Date: 11/5/2013

WS view: two outfall CMP pipes with flap gates on concrete headwall.

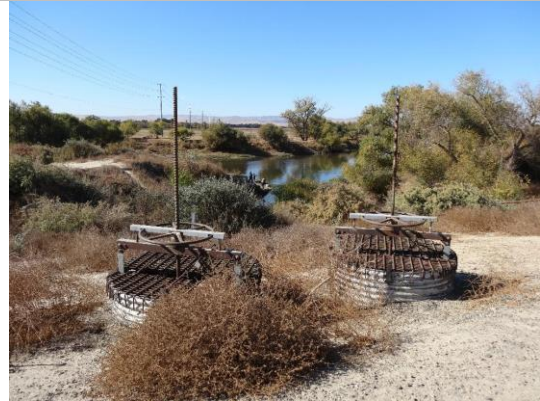
Photo 3 of 3 : UCIP_SP_2017_50218_43202.jpg

WS view: two slide gates in CMP risers on levee slope.

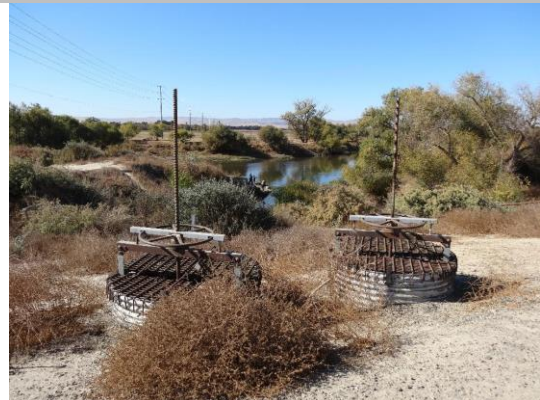
Photo 1 of 3 : UCIP_SP_2017_50217_43217.jpg

Comment Code					
Inspector Comment					
FS_ID:50217 DS_ID:22119 EP_NO: N/A Repair Type: No Action Needed Crossing Status: Found UCIP Comments: 08/23/2016: WS flapgates were held open by a piece of wood. Pipes may be used temporarily for irrigation. (K. Fazel - UCIP)11/05/2013: working during field inspection. (P. Amatya - DWR) FIELD_STRUCT_DESC: 2 of 2: Gravity drain structure. Two 48-inch CM pipes through the levee 25.5 feet below the crown. Slide gates in CM pipe risers on the waterward slope. Flap gates on the waterward ends. Cobble spillway 70 feet in length to river. (Lateral Drain No. 5) installed by USCE 1961. O&M Manual SJR 006, Sept. 1961. FS Date: 11/5/2013

WS view: two CMP risers with slide gates on levee slope.

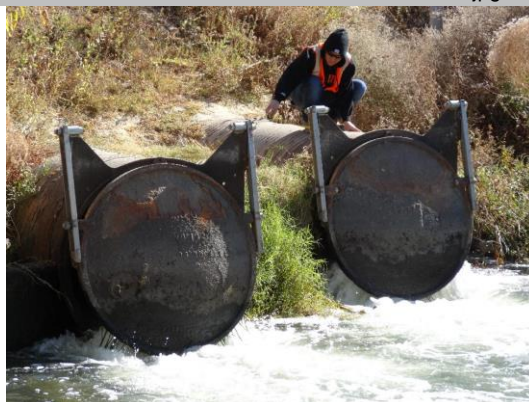
Photo 3 of 3 : UCIP_SP_2017_50217_43215.jpg

WS view: front view of two CMP outfall pipes with flap gates on levee slope.

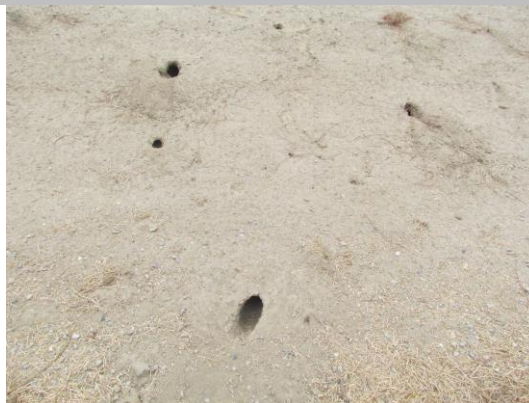
Photo 1 of 2 : SP_2017_RD2063_112_11_20170411_00004.jpg

LM Start	1.71	Rating **	A/W	Issue No.	11
LM End	1.74	Issue Type +	Ma	Location *	LS
Category	Earthen Levee			GPS Latitude/Longitude	
				Start	End
Item	Animal Control			37.459209 °	37.458964 °
				-121.033126 °	-121.033420 °
DWR ID	DWR_RD2063_01_s_2012_11				
Comment Code					
A3 : No rodents visible, but rodent burrows visible; need to backfill and compact or grout burrows.					
Inspector Comment					
Several rodent holes noted on landward slope.

Looking at several rodent holes on landward slope.

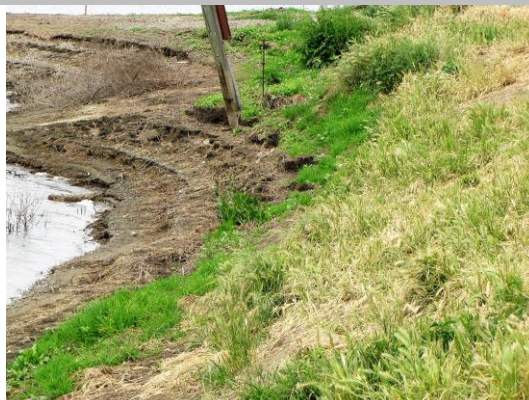
Photo 1 of 2 : SP_2017_RD2063_112_59_20170411_00121.jpg

Looking downstream at minor erosion on waterward slope.

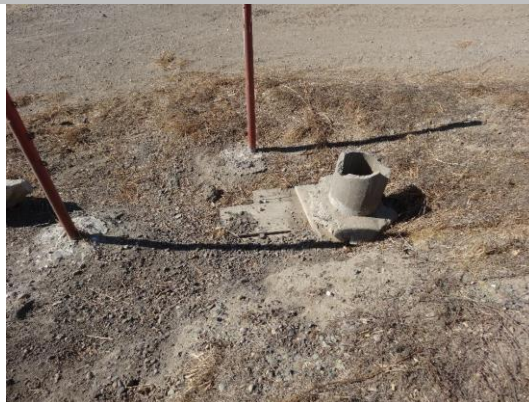
Photo 2 of 3 : UCIP_SP_2017_24404_43344.jpg

LM Start	2.09	Rating **	M	Issue No.	64
LM End	2.09	Issue Type +	En	Location *	LS
Category	Supplemental			GPS Latitude/Longitude	
				Start	End
Item	DWR UCIP Field Study			37.454125 °	37.454125 °
				-121.032240 °	-121.032240 °
DWR ID					
Comment Code					
Inspector Comment					
FS_ID:24404					
DS_ID:22078					
EP_NO: N/A					
Repair Type: Non-Urgent					
Crossing Status: Found					
UCIP Comments: Concrete distribution box with alfalfa valve not found at the waterward toe.Two steel standpipes and dismantled concrete standpipe on waterside levee toe.Concrete distribution box 50 ft off the levee center.					
FIELD_STRUCT_DESC: 30-inch CM pipe through the levee 16.5 feet below the crown. Slide gate in concrete distribution box 50 ft off the levee. Underground irrigation system. Installed by USCE 1961. O&M Manual SJR 006, Sept. 1961.					
FS Date: 11/5/2013

WS view: a dismantled concrete pipe on levee toe.

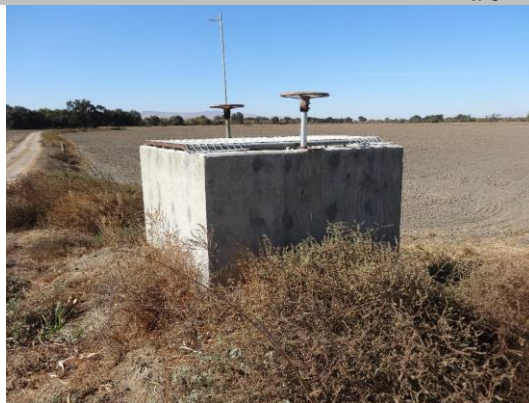
Photo 3 of 3 : UCIP_SP_2017_24404_43343.jpg

WS view: concrete distribution box with slide gate off the levee toe.

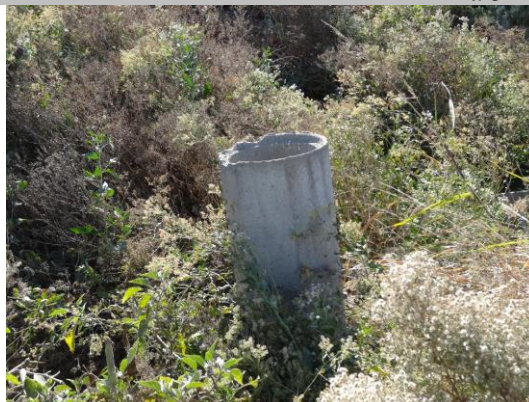
Photo 1 of 3 : UCIP_SP_2017_51823_43348.jpg

LM Start	2.27	Rating **	A/W	Issue No.	65
LM End	2.27	Issue Type +	Ma	Location *	LS
Category	Supplemental			GPS Latitude/Longitude	
				Start	End
Item	DWR UCIP LMA Responsibility			37.451946 °	37.451946 °
				-121.030672 °	-121.030672 °
DWR ID					
Comment Code					
Inspector Comment					
FS_ID:51823					
DS_ID:22081					
EP_NO: N/A					
Repair Type: No Action Needed					
Crossing Status: Found					
UCIP Comments: - concrete standpipe on waterside toe.- concrete distribution box on landside.- an alfalfa valve on waterside toe.					
FIELD_STRUCT_DESC: 30-inch CM pipe through the levee 12.0 feet below the crown. Flap gate on waterward end. Slide gate in distribution box on landward end. Concrete "U" headwall on the waterward end.					
O&M Manual SJR 006, Sept. 1961.					
FS Date: 11/5/2013

WS view: concrete standpipe on levee toe.

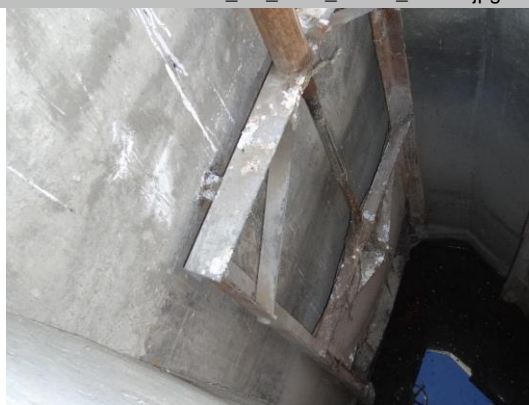
Photo 3 of 3 : UCIP_SP_2017_51823_43346.jpg

LS view: slide gate in concrete distribution box.

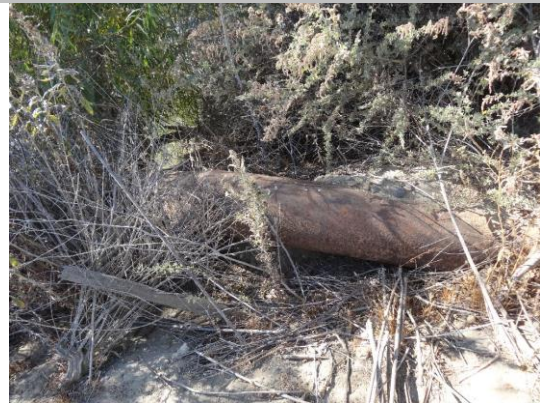
Photo 1 of 3 : UCIP_SP_2017_24427_43439.jpg

Comment Code					
Inspector Comment					
FS_ID:24427					
DS_ID:22085					
EP_NO: N/A					
Repair Type: Non-Urgent					
Crossing Status: Found					
UCIP Comments: Abandoned steel pipe and service pole on waterside.					
Pump not found on river bank. CMP riser on waterside slope. Slide					
gate not found in CMP riser. Steel pipe riser on waterside					
berm.Damaged PVC standpipe on waterside slope.					
FIELD_STRUCT_DESC: Abandoned 24-inch CM pipe through the					
levee 10.0 feet below the crown. 20-inch standpipe 3.0 feet from the					
landward toe. 12-inch pipe across the berm and into CMP riser on the					
waterward slope. Installed by USCE 1961. O&M Manual SJR 006, Sept.					
1961.					
FS Date: 11/5/2013

WS view: abandoned steel pipe on river bank. No pump found on river bank.

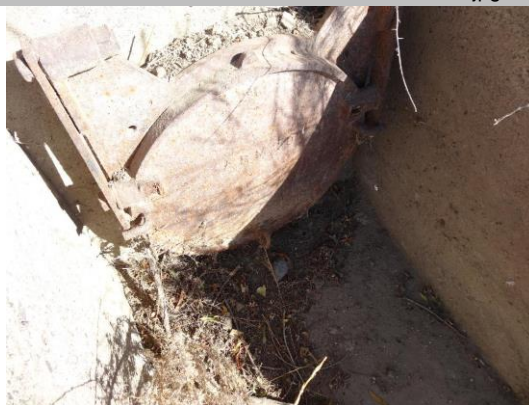
Photo 2 of 3 : UCIP_SP_2017_24435_43483.jpg

LM Start	2.62	Rating **	M	Issue No.	68
LM End	2.62	Issue Type +	Ma	Location *	LS
Category	Supplemental			GPS Latitude/Longitude	
				Start	End
Item	DWR UCIP LMA Responsibility			37.448233 °	37.448233 °
				-121.026521 °	-121.026521 °
DWR ID					
Comment Code					
Inspector Comment					
FS_ID:24435					
DS_ID:22086					
EP_NO: N/A					
Repair Type: Non-Urgent					
Crossing Status: Found					
UCIP Comments: Both pipe ends 70 ft off the levee center.Cleaning and cleaning of inlet/outlet pipe needed.					
FIELD_STRUCT_DESC: 24-inch CM pipe through the levee 12.0 feet below the crown. Flap gate on the waterward end. Concrete headwall on both ends. Installed by USCE 1961. O&M Manual SJR 006, Sept. 1961.					
FS Date: 11/5/2013

WS view: U shaped headwall outlet structure and pipe with flap gate.

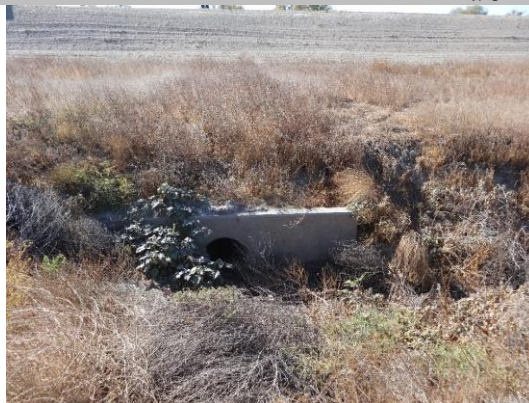
Photo 3 of 3 : UCIP_SP_2017_24435_43482.jpg

LS view: concrete headwall with CMP 70 ft off the levee center.

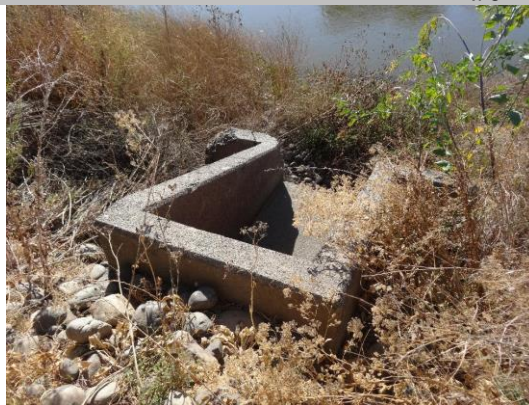
Photo 1 of 3 : UCIP_SP_2017_25023_45102.jpg

LM Start	2.68	Rating **	A/W	Issue No.	69
LM End	2.68	Issue Type +	Ma	Location *	LS
Category	Supplemental			GPS Latitude/Longitude	
				Start	End
Item	DWR UCIP LMA Responsibility			37.447475 °	37.447475 °
				-121.026017 °	-121.026017 °
DWR ID					
Comment Code					
Inspector Comment					
FS_ID:25023 DS_ID:22087 EP_NO: N/A Repair Type: No Action Needed Crossing Status: Found UCIP Comments: Both pipe ends about 85 feet off the levee center. FIELD_STRUCT_DESC: 24-inch CM pipe through the levee 20.3 feet below the crown. Flap gate on the waterward end. Concrete headwall on both ends. Installed by USCE 1961. O&M Manual SJR 006, Sept. 1961. FS Date: 11/5/2013

WS view: U typed concrete headwall on river bank.

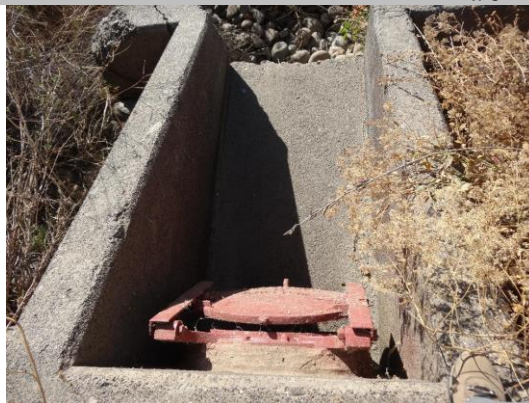
Photo 2 of 3 : UCIP_SP_2017_25023_45101.jpg

WS view: pipe, flap gate, and concrete headwall on river bank.

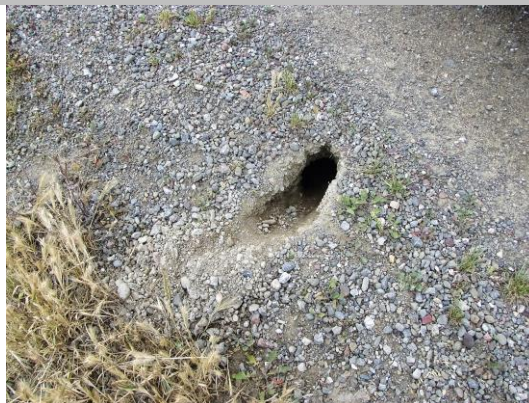
Photo 1 of 1 : SP_2017_RD2063_112_60_20170411_00123.jpg

Looking at typical rodent hole on landward shoulder.

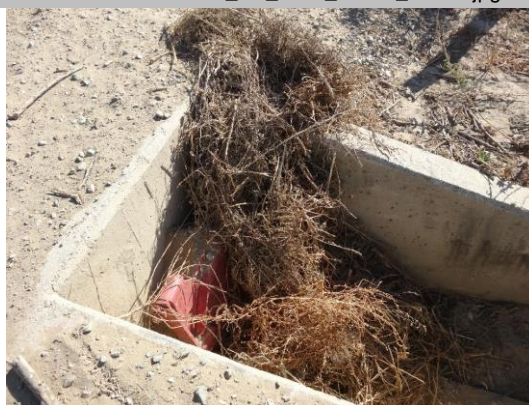
Photo 1 of 3 : UCIP_SP_2017_24443_43522.jpg

LM Start	2.93	Rating **	M	Issue No.	70
LM End	2.93	Issue Type +	Ma	Location *	LS
Category	Supplemental			GPS Latitude/Longitude	
				Start	End
Item	DWR UCIP LMA Responsibility			37.443871 °	37.443871 °
				-121.025775 °	-121.025775 °
DWR ID					
Comment Code					
Inspector Comment					
FS_ID:24443					
DS_ID:22088					
EP_NO: N/A					
Repair Type: Non-Urgent					
Crossing Status: Found					
UCIP Comments: - clear and clean debris					
FIELD_STRUCT_DESC: Abandoned 24-inch CM pipe through the					
levee 9.5 feet below the crown. Flap gate on the waterward end. Pipe					
open on landward end. Concrete headwall on both ends. O&M Manual					
SJR 006, Sept. 1961					
FS Date: 11/5/2013

WS view: U typed concrete headwall on levee slope.

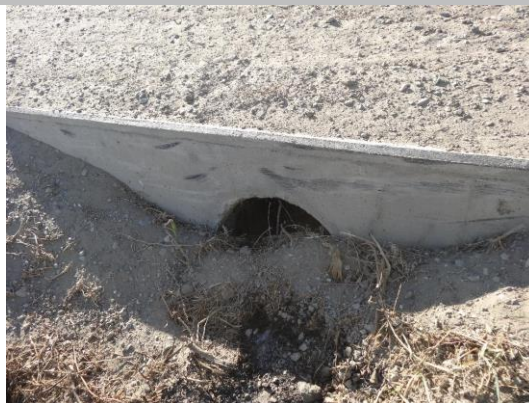
Photo 3 of 3 : UCIP_SP_2017_24443_43520.jpg

WS view: pipe, flap concrete headwall with soil debris blocking the inlet.

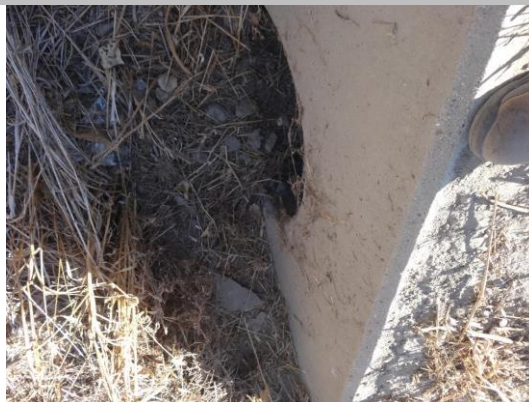
Photo 3 of 3 : UCIP_SP_2017_24469_43643.jpg

LS view: CM pipe and concrete headwall on levee slope. Debris blocking inlet pipe.

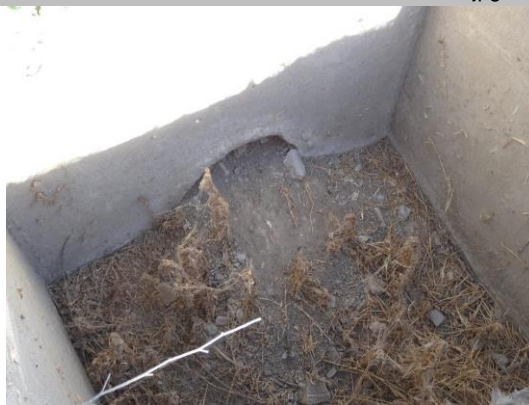
Photo 3 of 3 : UCIP_SP_2017_24485_43665.jpg

LS view: inside view of inlet box on levee toe. Debris blocking inlet pipe.

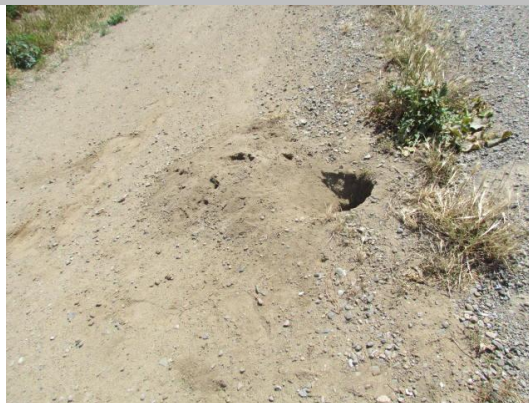
Photo 2 of 2 : SP_2017_RD2063_112_29_20170411_00010.jpg

Looking south at typical rodent hole on landward shoulder.

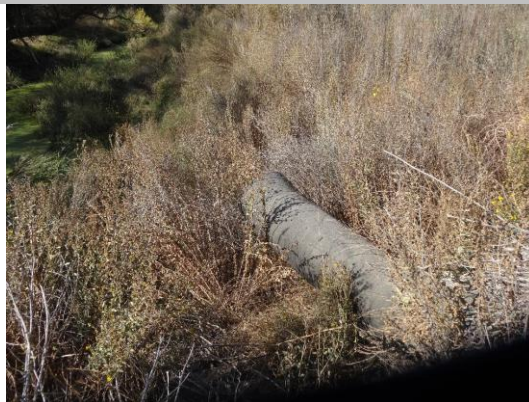
Photo 2 of 3 : UCIP_SP_2017_25025_45109.jpg

WS view: discharge pipe end on levee toe. No flap gate.

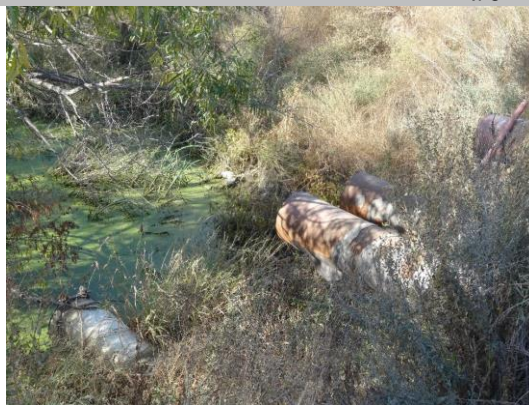
Photo 2 of 3 : UCIP_SP_2017_25026_45114.jpg

WS view: discharge pipes end on levee toe. No flap gates on right 3 pipes.

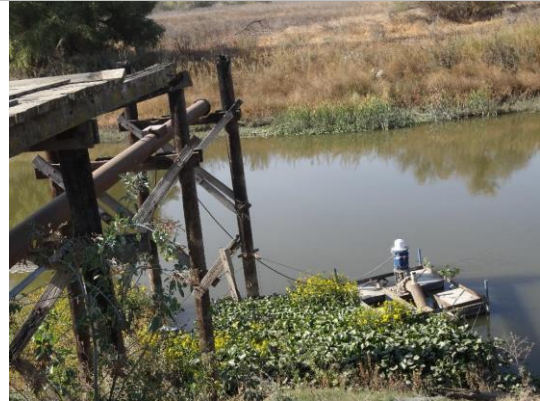
Photo 3 of 3 : UCIP_SP_2017_41669_45129.jpg

WS view: abandoned walkway, pipe (left) and pump on floating structure in the river.

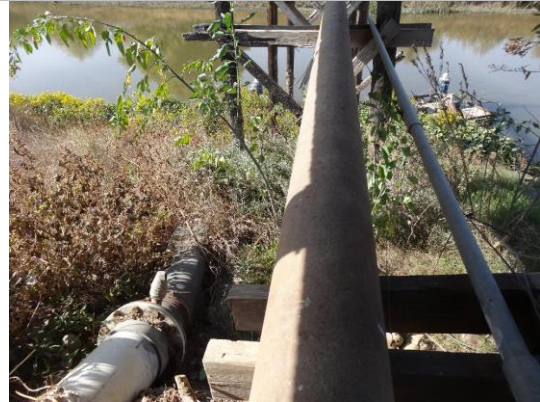
Photo 3 of 3 : UCIP_SP_2017_41670_43903.jpg

WS view: abandoned steel pipe (right), rubber pipe attached to steel pipe to pump on floating structure in the river.

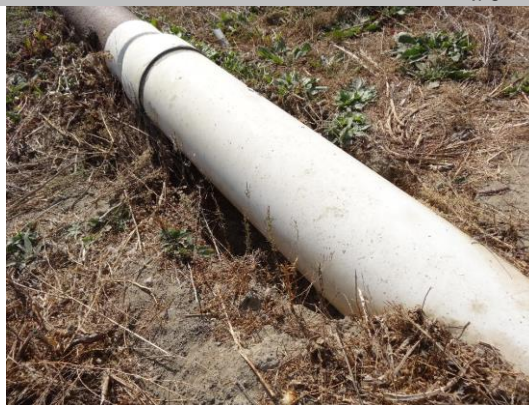
Photo 3 of 3 : UCIP_SP_2017_24628_43936.jpg

WS view: exposed pipe on levee slope. Erosion under the pipe.

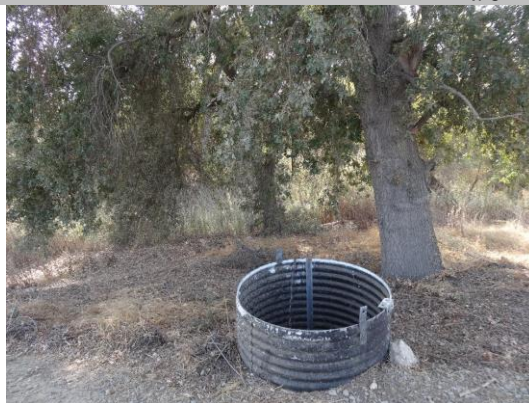
Photo 1 of 3 : UCIP_SP_2017_25031_45141.jpg

WS view: CMP riser with slide gate. Missing slide gate handwheel.

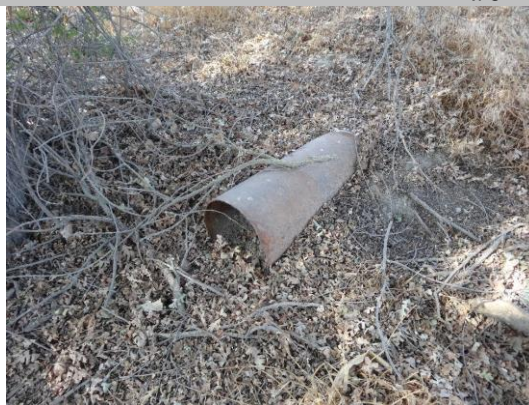
Photo 2 of 3 : UCIP_SP_2017_25031_45140.jpg

WS view: steel pipe with open-end on waterside slope.

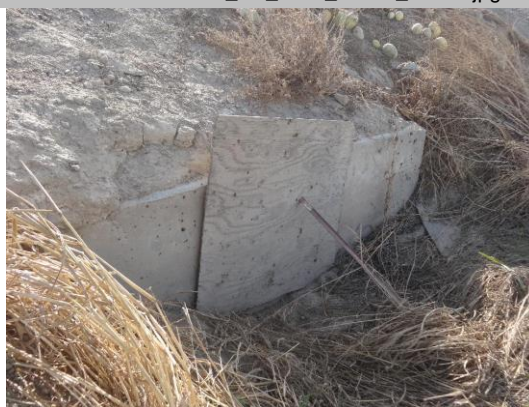
Photo 3 of 3 : UCIP_SP_2017_51825_43982.jpg

LS view: concrete headwall on levee end. Pipe opening blocked by plywood.

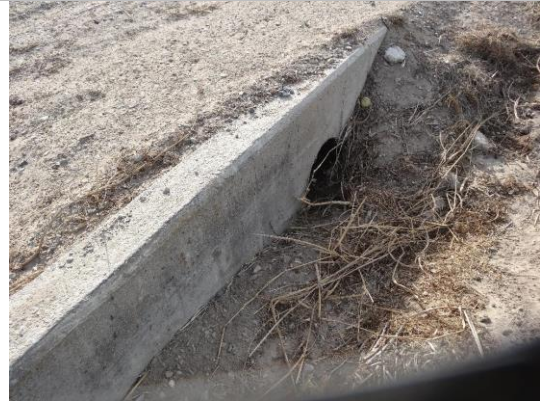
Photo 2 of 2 : UCIP_SP_2017_24645_43987.jpg

LS view: concrete headwall and partially blocked inlet opening.

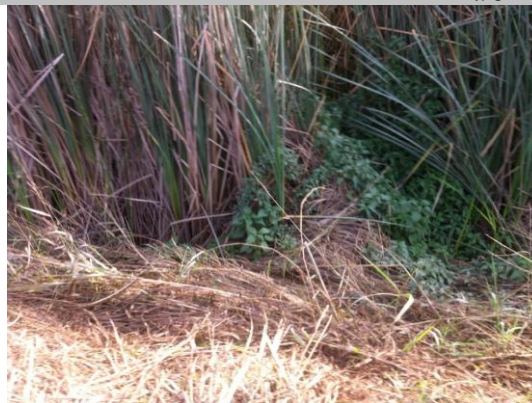
Photo 3 of 3 : UCIP_SP_2017_50222_43991.jpg

WS view: dense vegetation, no pipe visible.
